EPSON PRODUCT SUPPORT BULLETIN

Date:	12/12/2008	Originator:	TC
PSB #:	PSB.2009.01.002	Authorization:	Kps
Reference:	N/A	Total Pages:	5
Product(s):	Perfection 4990 Series, Perfection V700Photo / V750 M-PRO		
Subject:	Issues Scanning Large Film or X-rays

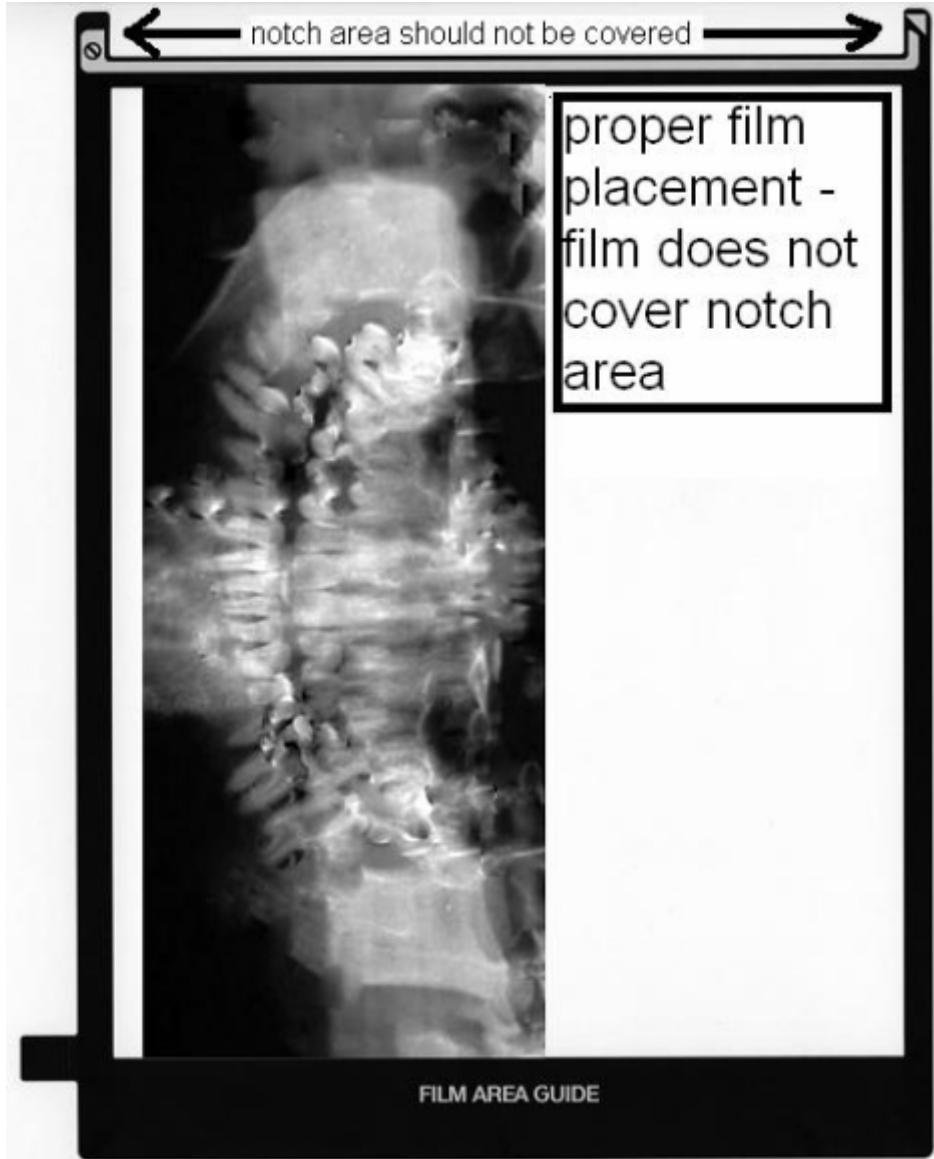
Below is the Film Area Guide for the Perfection 4990 Series / V700 / V750-M PRO scanners. This image shows the proper placement of a panoramic dental X-ray, where the film is placed below the notched area and does not cover any part of the white calibration area.

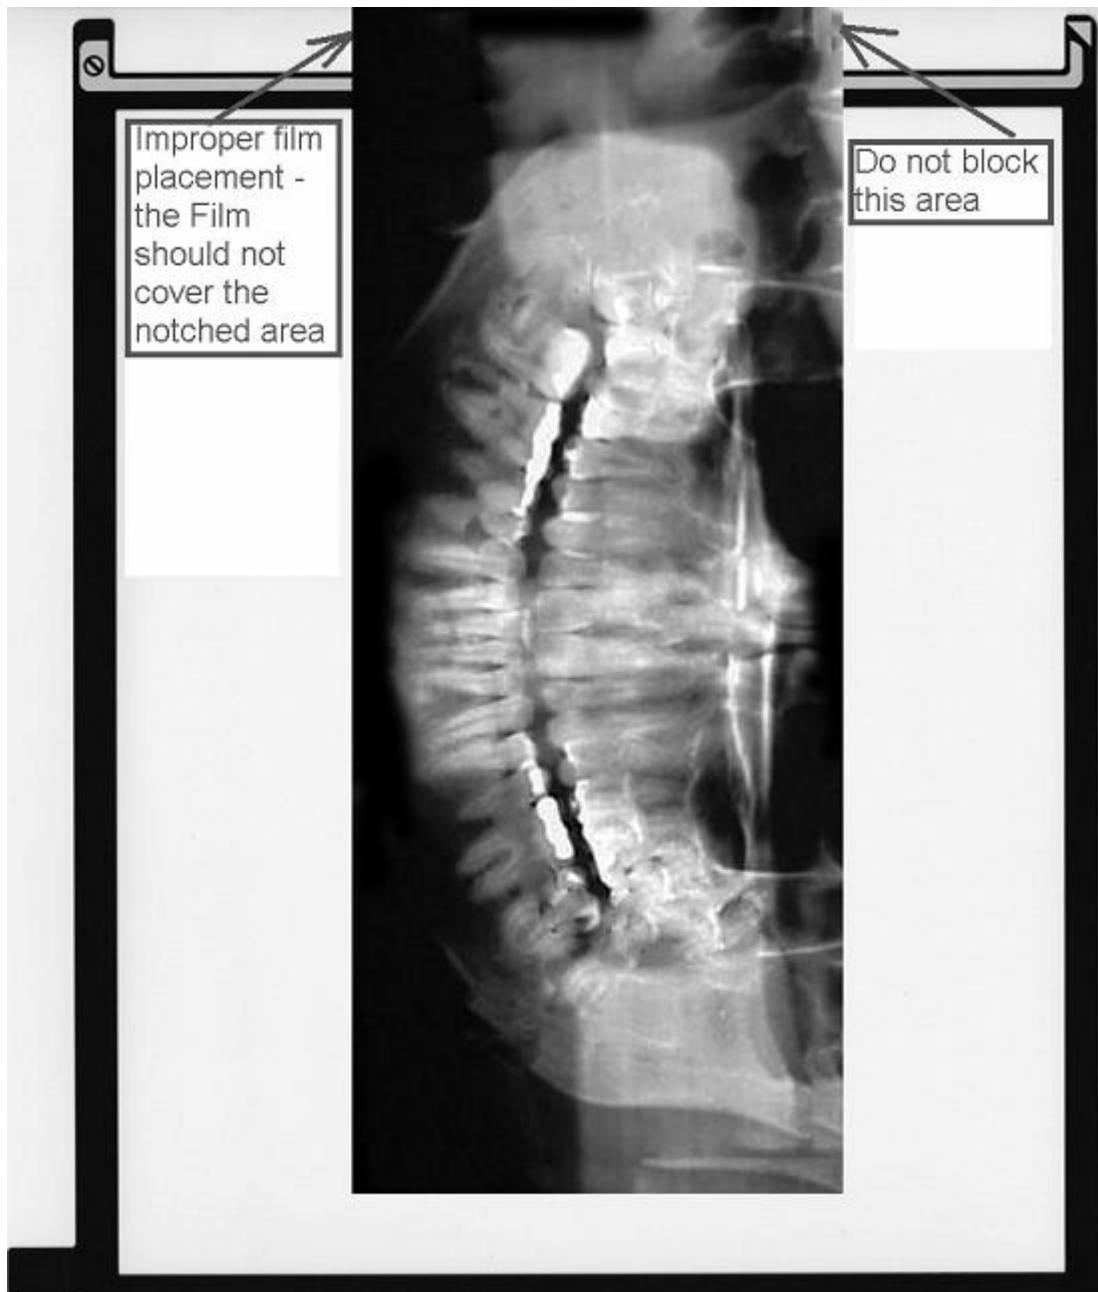
FILM AREA GUIDE

The picture below shows the film area guide for the Perfection 4990 Series / V700 / V750-M PRO scanners with improper film placement. The film is too high on the bed and is covering part of the white calibration notched area. Every time a film scan or preview is initiated, the scanner will perform an incorrect white calibration reading which causes scanned images to look "washed out" image or display lines.

If you are having issues scanning large film or X-rays on the Perfection series, please verify you are placing the film properly on the glass and are using the film area guide.

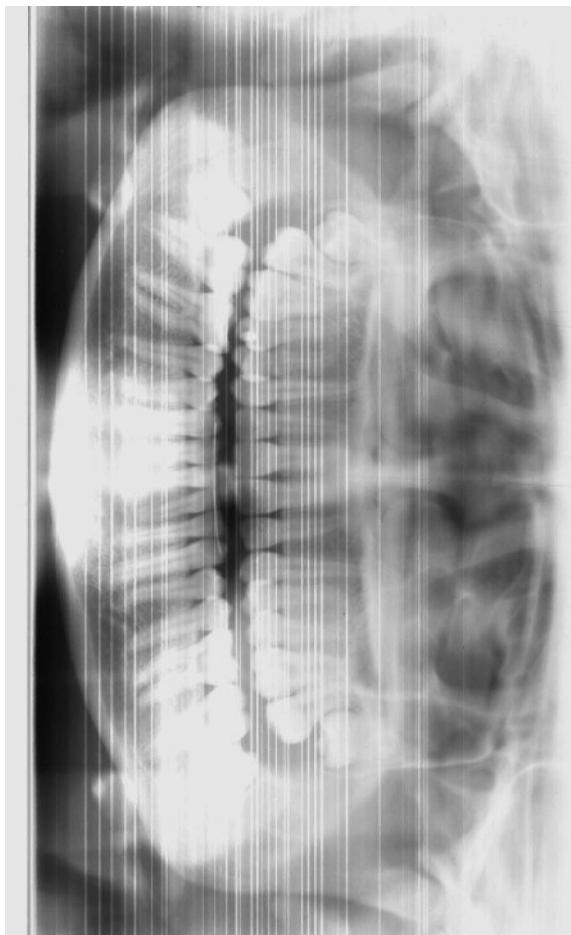
The image below is an example of the final scan when the film is not correctly placed on the bed. The film was placed in the area where the scanner takes a white calibration reading. Note the very light "washed out" areas and lines throughout the scan.
